# Plymouth's Elizabethan House

# The Elizabethan House

A survival from the late 1500s when Plymouth was a thriving port, the Elizabethan House has endured early 1900s slum clearance and the Blitz. Vital structural and strengthening works were carried out as part of Plymouth's Mayflower 400 commemorations. Project architect and SPAB Scholar Izaak Hudson explains the SPAB's unique involvement in the building and some of the challenges of the project.

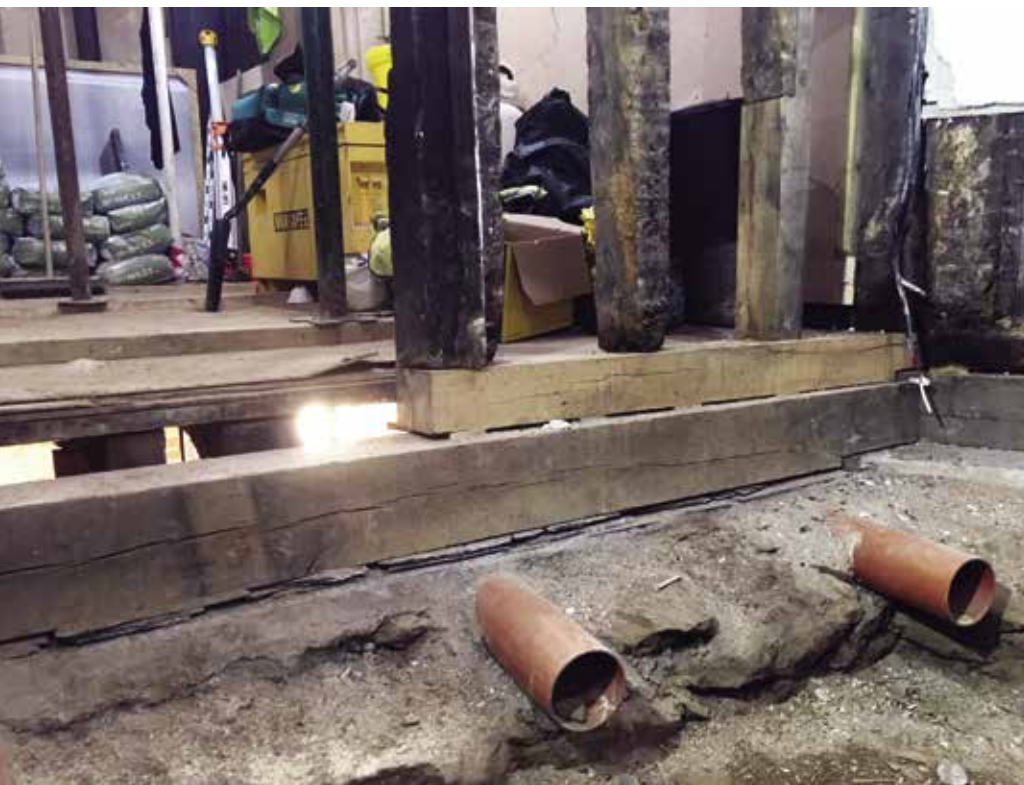
**Above** Oak sole plate repairs and ducts for radon protection on site

Initial analysis of the building with the project structural engineers, Fenton Holloway, showed that many of the issues could be resolved by careful intervention, such as fitch plates to beams, scarfed beam and joist ends to replace decay, internal ties within the walls, and steel strengthening plates. However, the condition of the slate-hung rear wall was of much greater concern. It was later discovered that many of the studs were only hanging from the slate battens and the wall had no footing at all, and extensive underpinning was required.

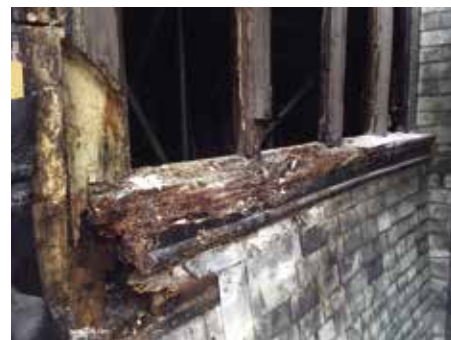
**Top** Rotten window cill and frame members uncovered for repair

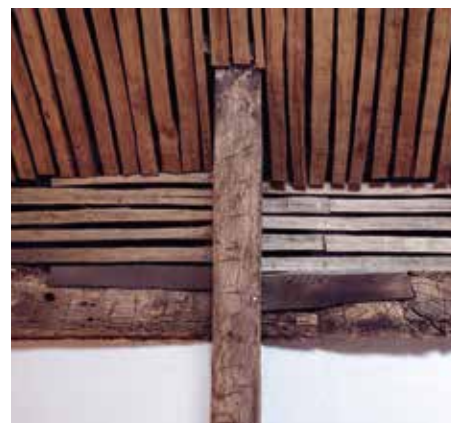
**Above** Pieced-in oak wall plate and chestnut ceiling laths

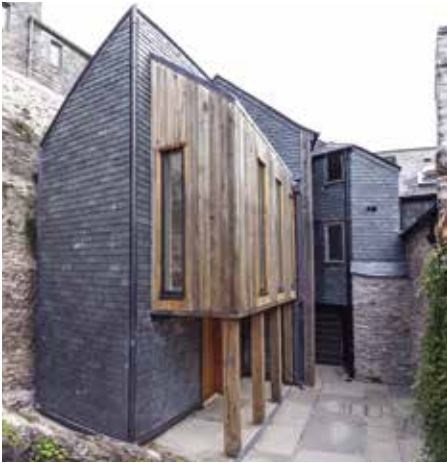
**Above** The new oak and Delabole slate rear extension

A proposal was developed for a two-storey extension to act as a buttress to the house and rear range oak roof trusses which were racking outwards. The extension would also house the new toilet, a meeting room and kitchen for museum staff, and plant and server rooms to service the new museum fit-out and particularly the intensive audio-visual installation. By housing all these services in the new slate and oak extension, the existing historic rooms all retain their original configuration.

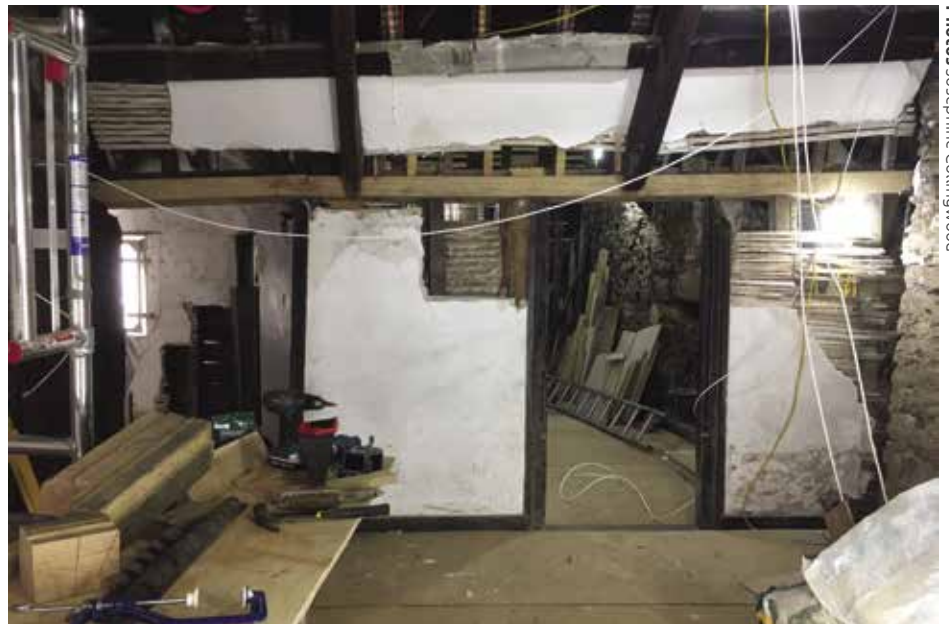
**Right** Repairs to the leaning spine wall

At the Elizabethan House, the lean of the central spine wall between the ranges caused by roof spread had reached a point where it would continue to lead out under its own weight without structural intervention. Of more serious consequence was the continual movement of the truncated rear range, and extensive water ingress though the slender rear wall (originally an internal partition). The rooms were quickly

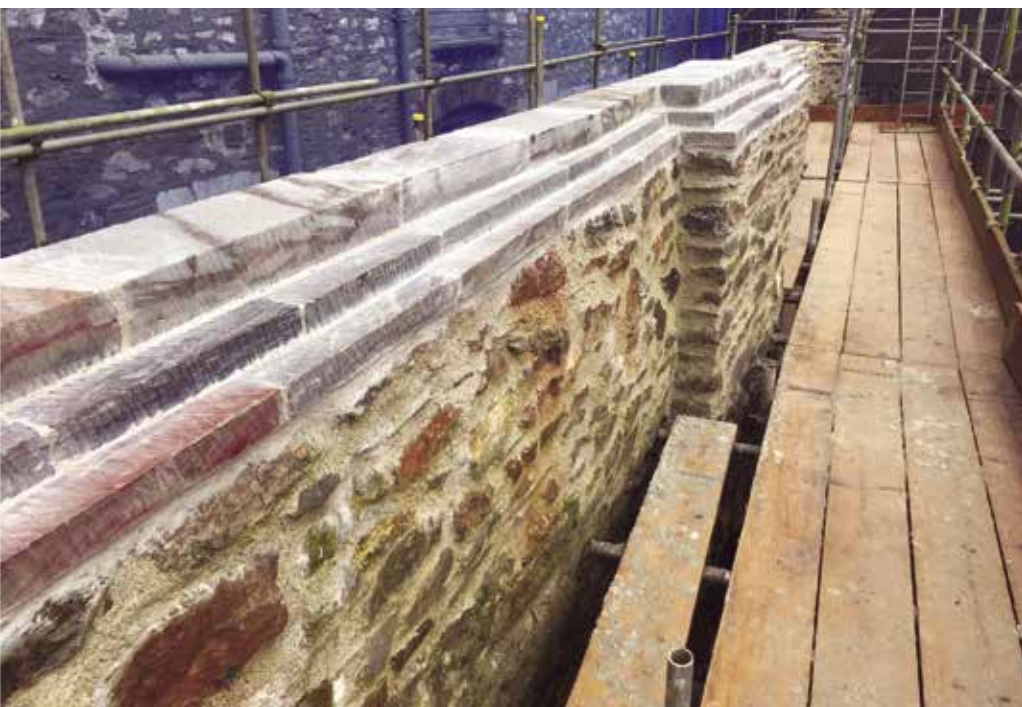
**Left** Repointing and new capping of the garden walls in Plymouth limestone

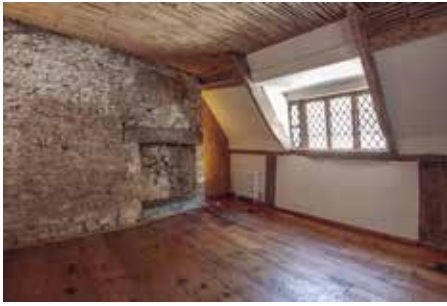
**Above** The top floor room following repairs

The exhibition designers asked for the main room on the top floor to be left in a partially completed state to reflect the exhibition design for the room detailing the building's construction. Again, this required some behind-the-scenes thought, such as installing black-painted boarding behind the laths to maintain separation through the ceiling. Although I was initially skeptical of leaving the ceiling unplastered, the variety of materials and light across them now makes this one of my favourite rooms in the building.
